**Flood Control Project Maintenance
Levee Inspections**
LMA District Cover Sheet
Spring 2020 Levee Inspection Results

Reclamation District No. 0784 Plumas Lake

Spring 2020 Levee Inspection Results

Waterway			Bank	Unit Miles
Unit No. 01 Yuba River			Left	2.21
	Spring (March - May)	Summer (June - August)	(September - November) Fall	Winter (December - February)
Unit Maintenance Rating (Fall Only)				
Date of Inspection	3/9/2020 - 3/9/2020			
DWR Inspector	Sterling York			
Accompanied By	Patrick Meagher RD 784

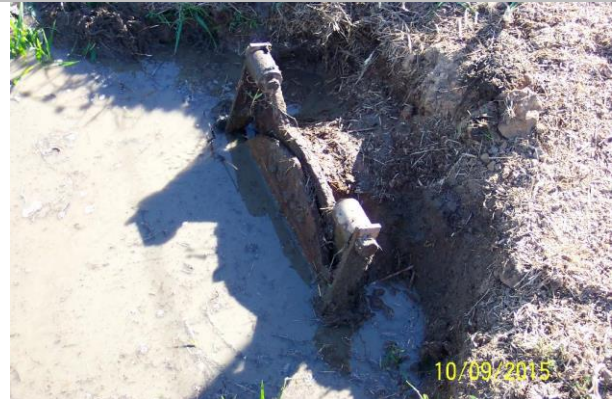
Photo 3 of 3 : UCIP_SP_2020_53550_74710.jpg

DS_ID:18593
FS_ID:53550
EP_NO: N/A
Repair Type: Non-Urgent
Crossing Status: Found
UCIP Comments: 2/1/2019 - An attempt was made to video inspect this pipe crossing on 8/15/2018 but conditions were too muddy inside the pipe. (P. Meagher)11/14/2016 - Photos added of exposed flap gate on WS and possible inlet location on LS. Condition remains as Non-Urgent because of inlet not being fully operable. Unknown if pipe will operate as designed during high water or if it is full of sediment.11/01/2015 - Waterside Flap Gate Uncovered. Photo sent to DWR Matt Hoffman on 3/3/2014. Fresh photo sent to DWR Pavel Kazi on 9/9/2015. Landside toe has never been able to be located. Requesting DWR inspector to change the status of this issue to "No Action Needed". (P.Meagher - RD784).Pipe buried on LS toe and flap gate is blocked by soil on WS toe. (W. Wylie - UCIP Inspector).
FIELD_STRUCT_DESC: 18-inch corrugated metal drainage pipe through the levee, 10 feet below the crown. Flap gate on the waterside (WS) end. [Additional Reference(s): DWR Levee Log, 2005. USACE Sacramento O&M Manual 145, August 1955 (Station 91+50)].

LM Start	3.96	Rating **	M	Issue No.	23 (cont)
LM End	3.96	Issue Type +	Ma	Location *	
Category	Supplemental			GPS Latitude/Longitude	
				Start	End
Item	DWR UCIP LMA Responsibility			39.019787 °	39.019787 °
				-121.513386 °	-121.513386 °
DWR ID	18593
